# THE NARROWS STREAM BANK RESTORATION AND PROTECTION PROJECT

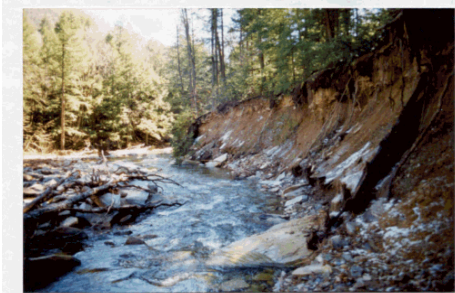
*Upstream site 1 – Before the start of the project – February 1999*

Downed trees in the stream, in turn, were causing additional bank erosion and channel scour by redirecting the flow towards the banks.

The near vertical eroding banks, which were approximately 15 feet high, were receding at rates approaching nearly 10 feet per year, generating over 8000 tons of sediment.

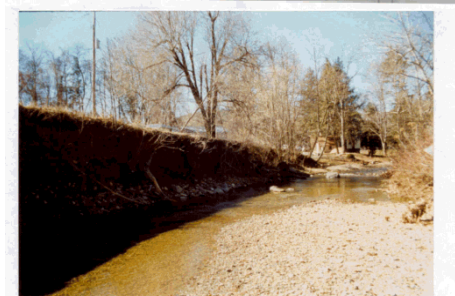
*Downstream site 2 – Before the start of the project – February 1999*

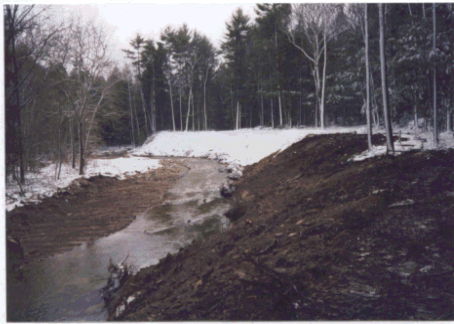
*Upstream Site 1 – After completion of the project  
– March 1999*

The Narrows project involved the reshaping and stabilization of approximately 800 feet of critically eroding bank at two sites. In addition to smoothing and reducing the bank slope, the project planned for the installation of “root wads” and large native rock to protect and stabilize the eroding toes of the high banks. The project also involved the planting of trees and grasses to stabilize the upper portions of the banks, control erosion, improve visual quality, and create a riparian buffer and habitat.

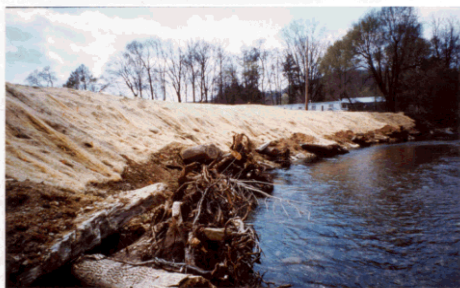
*Downstream Site 2 – After completion of the project  
– March 1999*

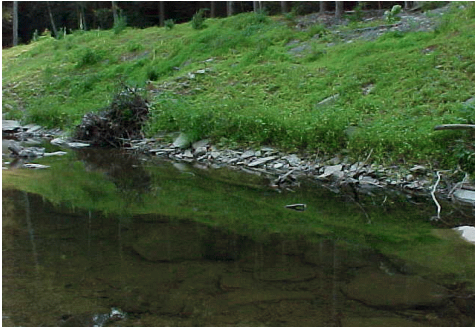
*Upstream Site 1 – August 2001*

Stream bank erosion rates and instream sedimentation have been greatly reduced with nearly 8000 tons of potential sediment prevented from entering the creek.

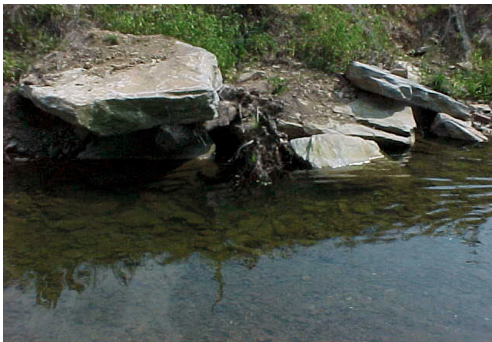
*Downstream Site 2 – Close up of root wad, August 2001*

Stream bottoms have returned to a clean gravel condition with no evidence of siltation. Native trees from natural successions have returned to the gravel bars on the opposite banks. In addition to stabilizing the streambanks, the rootwads are providing sheltered habitat to native trout that have returned to the restored areas in significant numbers.
